# **Environmental Assessment**

## **Proposed New Claflin University Public Health Center**

**783 Goff Avenue  
Orangeburg, South Carolina**

Asbestos Survey  
Claflin University Academic Building  
783 Goff Avenue  
Orangeburg, South Carolina

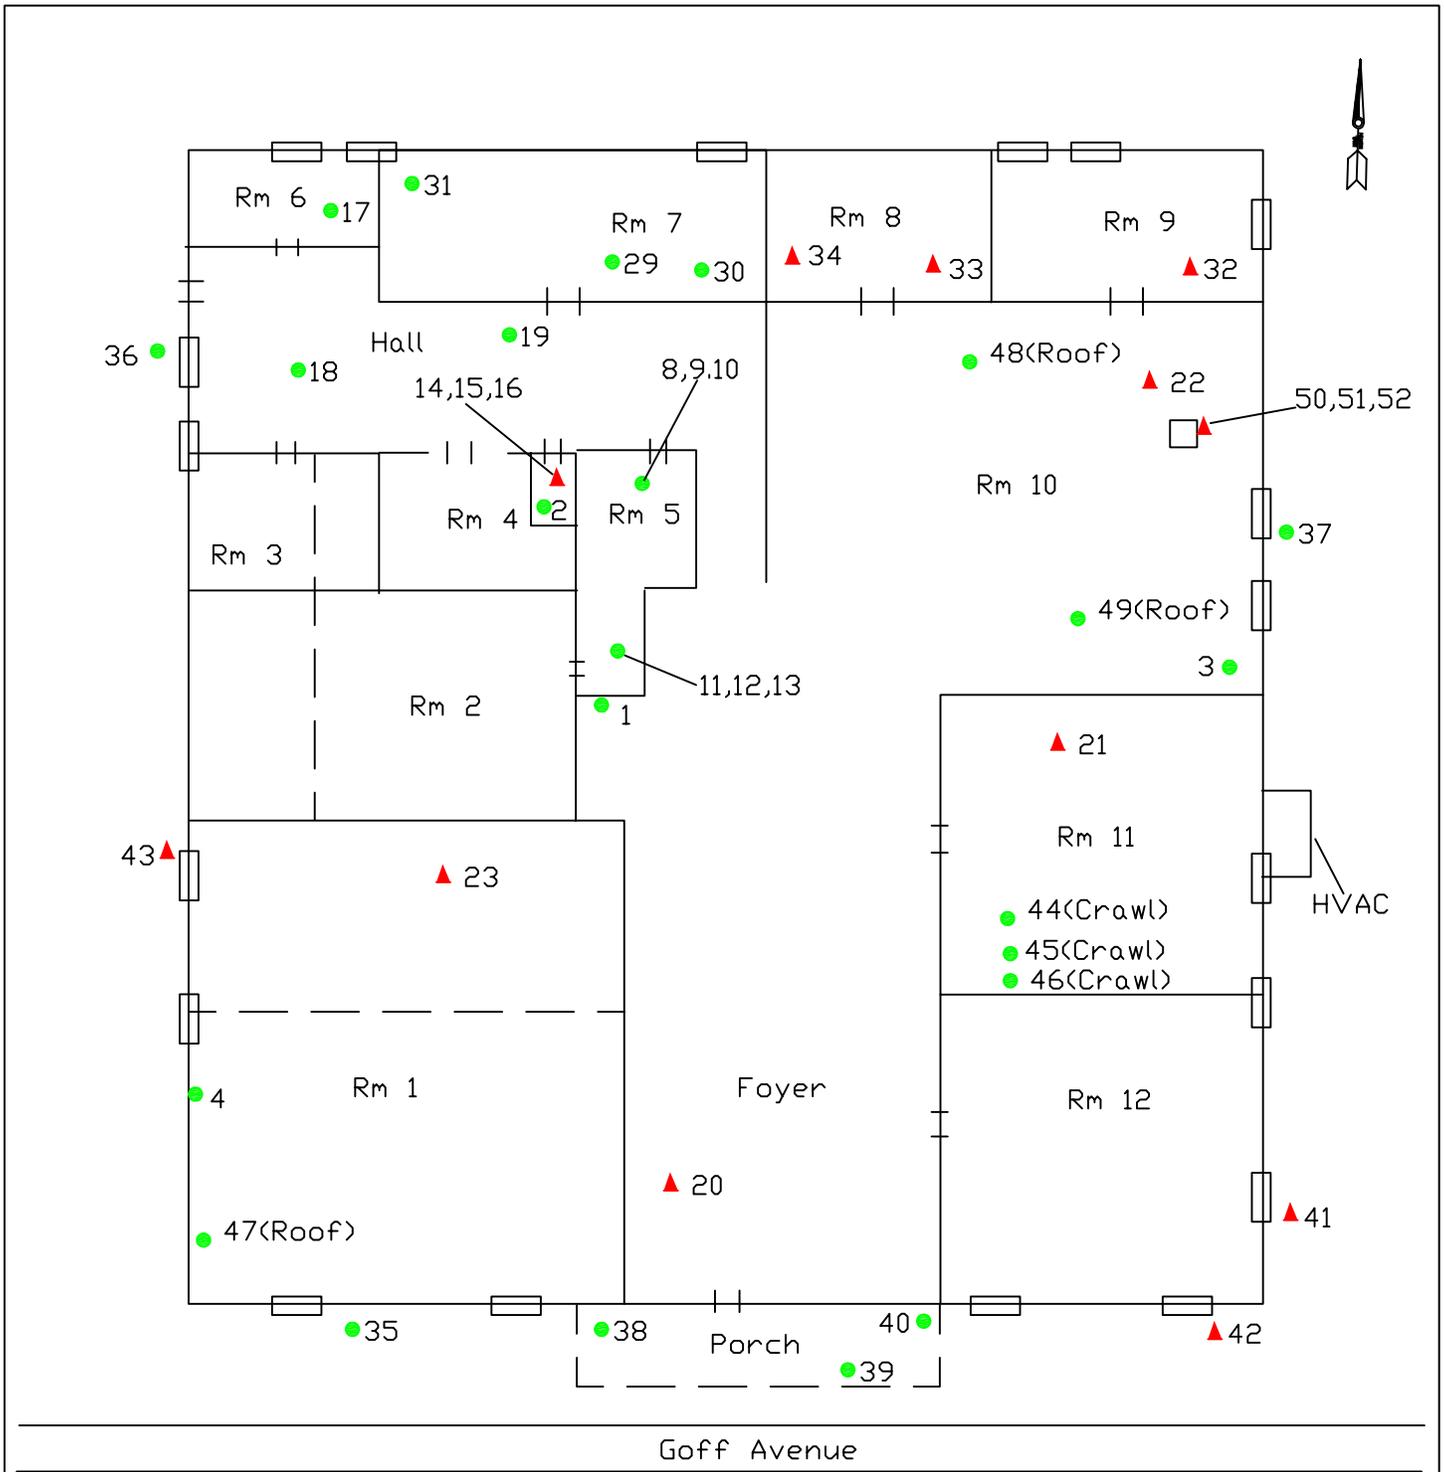
**FIGURE 1**

*DESCRIPTION:*  
 1st Floor Plan  
 Showing Sample  
 Locations  
 (Map Not To Scale)

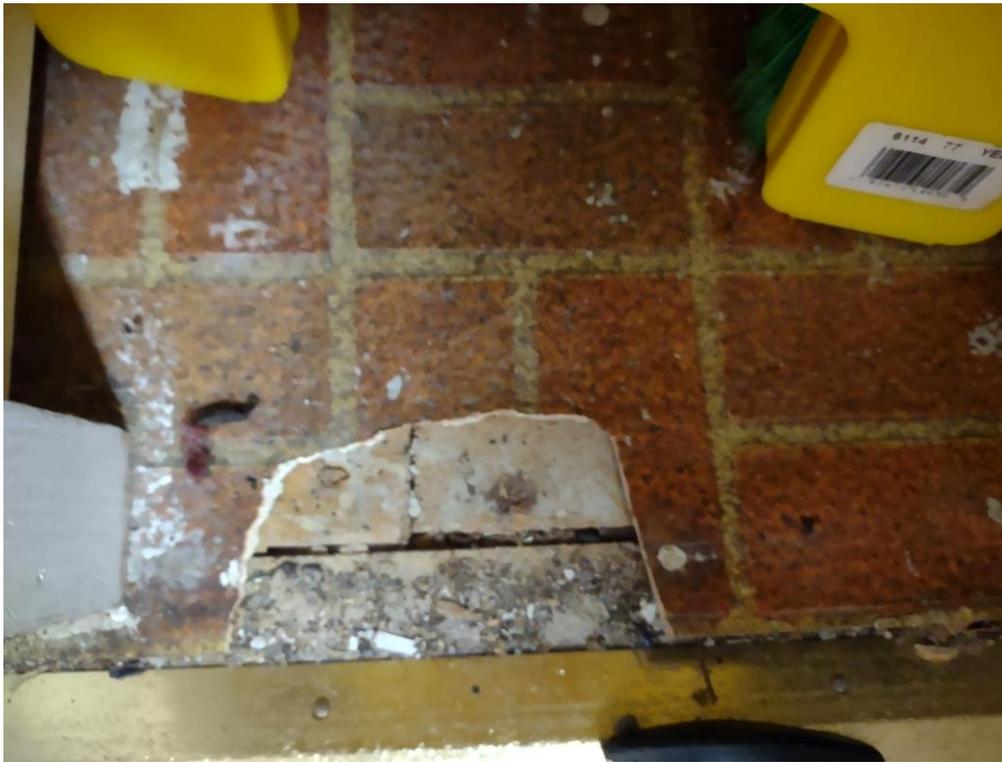
**Photograph 3** – The brick pattern vinyl sheet flooring shown here in a 1<sup>st</sup> floor closet contains 40% Chrysotile asbestos.

In the event of future disturbance of these asbestos containing materials, there is the potential for concentrations of asbestos fibers to be released into the air. State and Federal regulations require the removal of asbestos-containing materials prior to any disturbance caused by renovation or demolition. It is recommended that the removal of any ACMs be conducted by a licensed Asbestos Abatement Contractor.

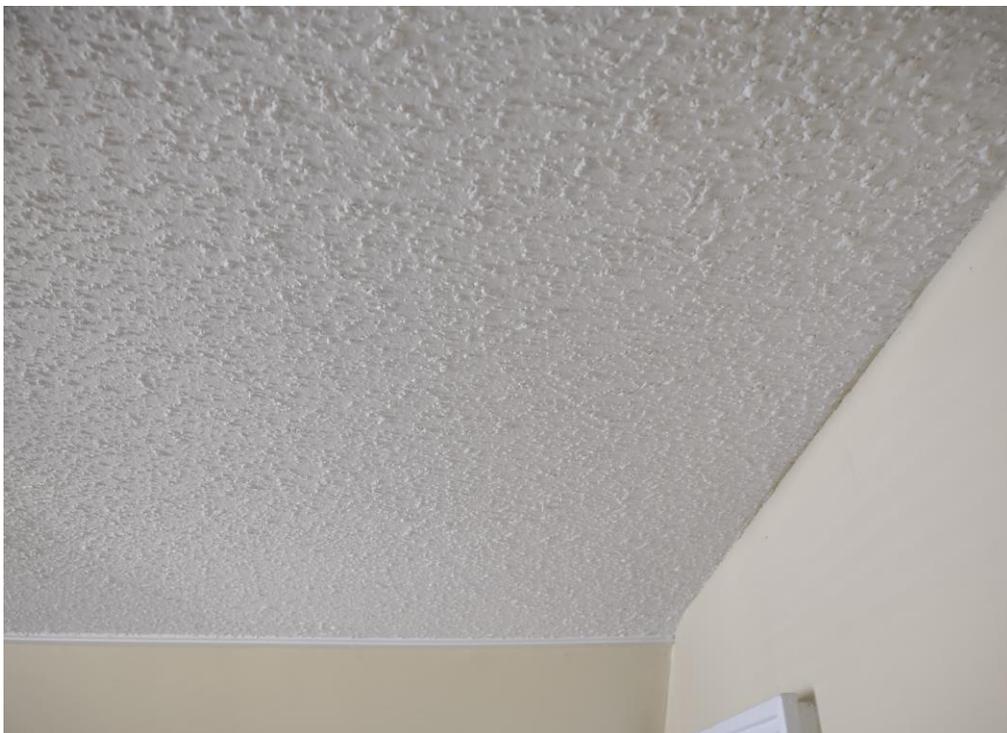
**Photograph 4** – This photo shows white ceiling texture throughout the subject building. This material contains 5% Chrysotile asbestos.

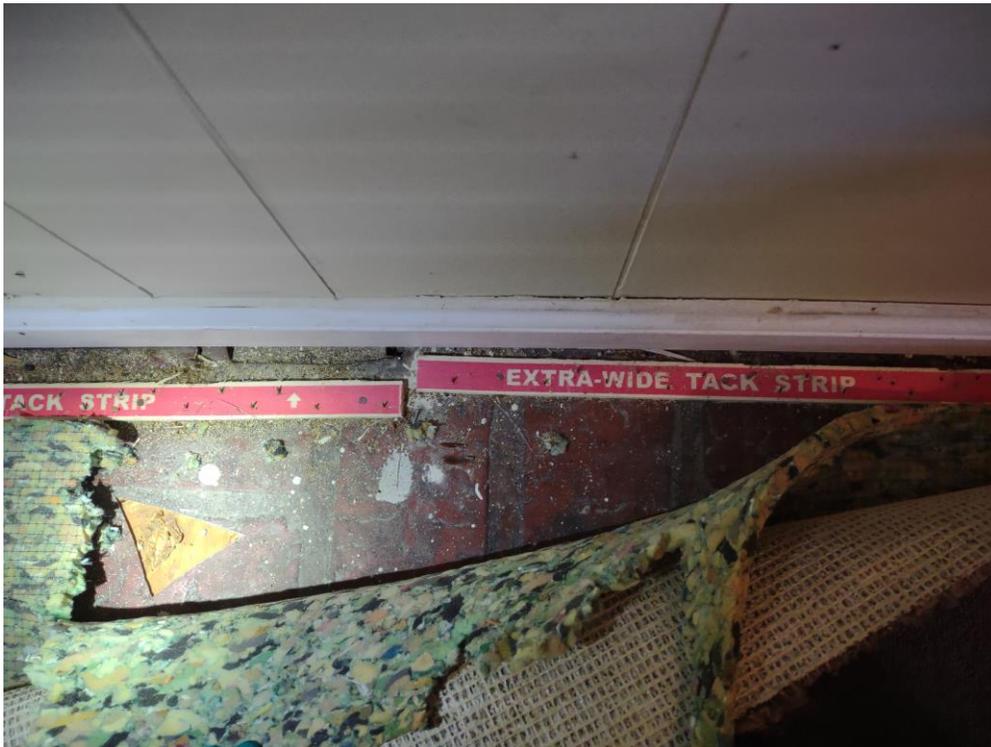
**Photograph 5** – The wide pattern vinyl sheet flooring shown here in Rooms 8 & 9 is beneath carpet and contains 40% Chrysotile asbestos.

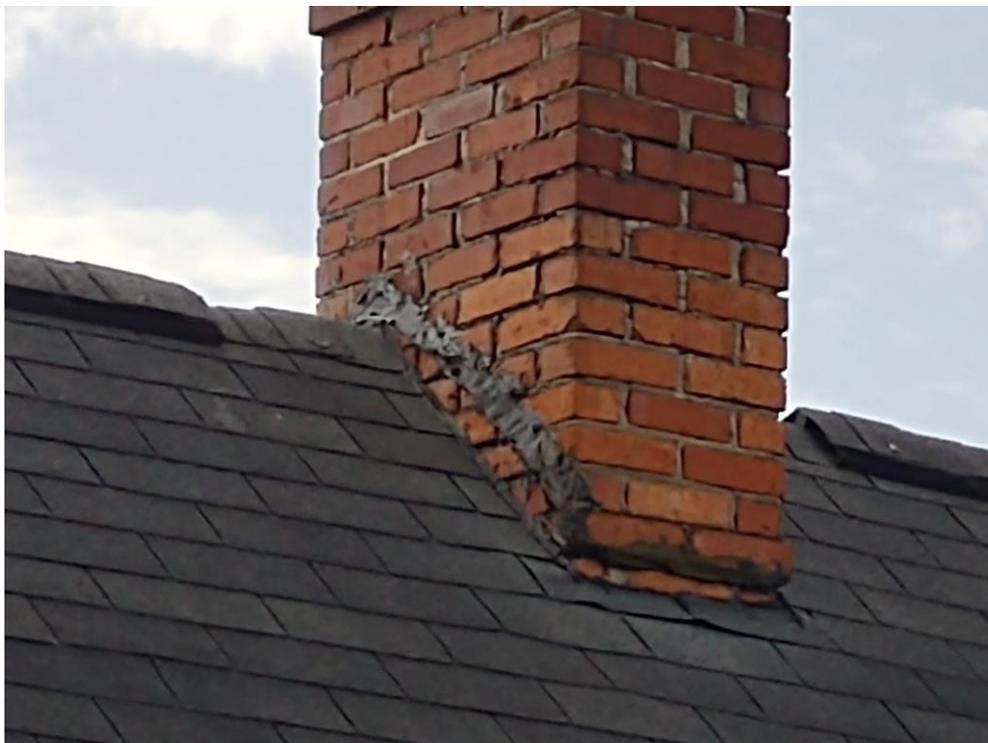
**Photograph 6** – This photo shows mastic at the base of the chimney. This mastic contains 5% Chrysotile asbestos.

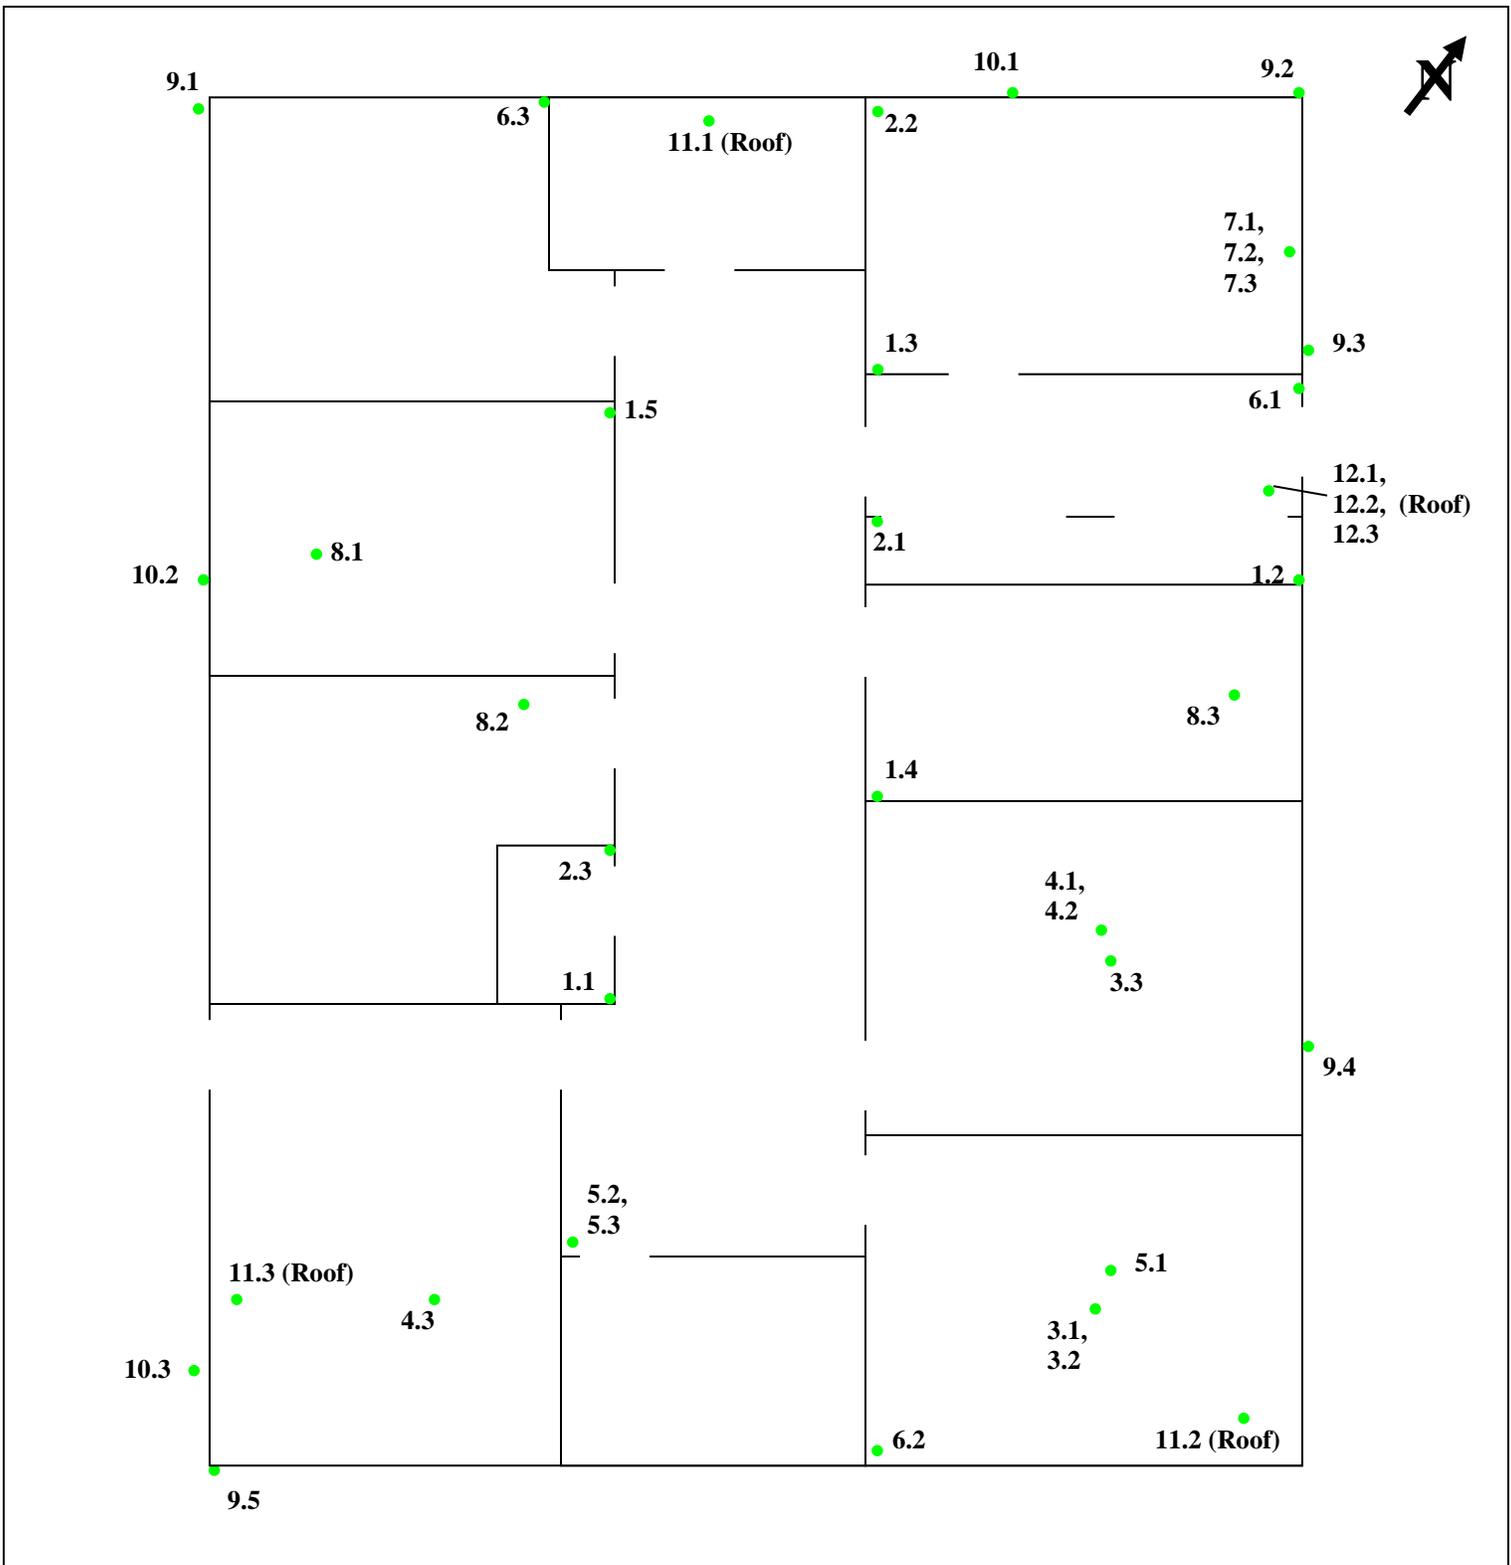
**Figure 1**  
 Floor Plan Showing Sample Locations  
 ▲ = Positive Asbestos Sample  
 ● = Negative Asbestos Sample
